Considerations on the Vulnerability of Architectural Heritage. Case study: the church of El Sagrario, Cuenca, Ecuador

Gema Mariela Zamora Cedeño

María del Cisne Aguirre Ullauri

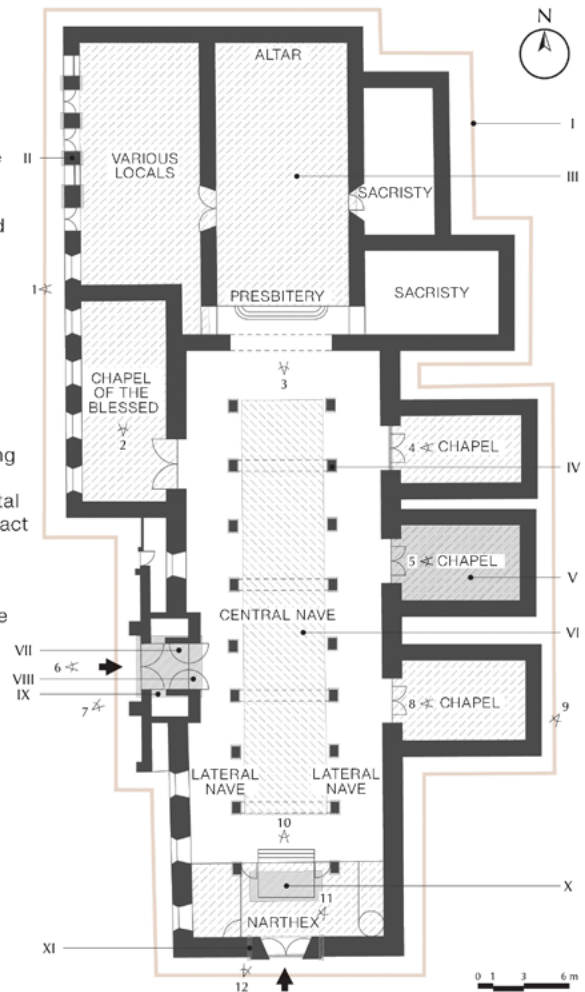
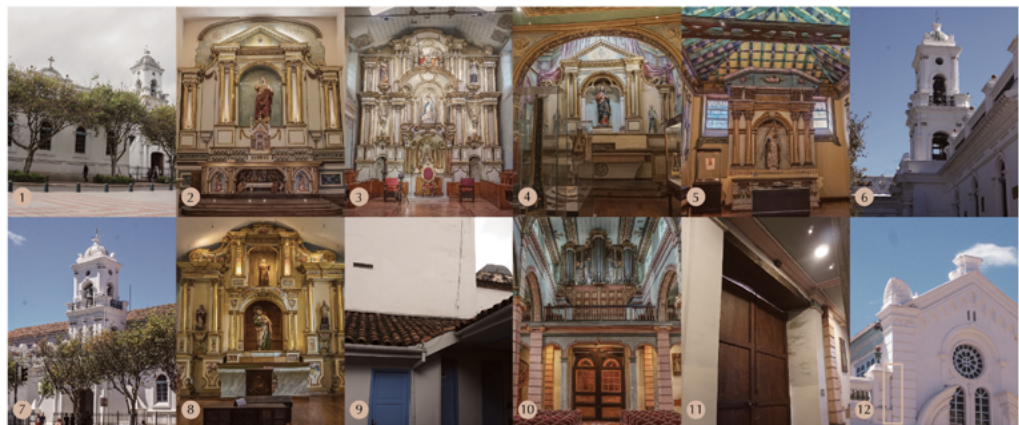
FIGURE 11. Thematic plan of structural flaws in the church of El Sagrario (Photo: Gema Zamora, 2018; courtesy: the church of El Sagrario, Ecuador).

The structural faults of the church of El Sagrario are detailed with greater precision, where the aspects in the architectural morphology that classify it as vulnerable are determined (Figure 11). The configuration of the floor plan reveals asymmetry due to the annexed bodies that were included in the transformations of the building, a harmful characteristic, as they had to withstand external forces; the absence of trusses or correct distribution of support in these structures can cause the collapse of the roof toward the interior and fractures in the upper area of the walls; the tubular organ in the choir, on the upper floor of the building, represents a considerable load and is, therefore, harmful in a high-intensity earthquake; the slenderness of the bell tower and the additional loads of the bells describe a possible individual behavior of these com-

FAULT DESCRIPTION

POTENTIAL THREATS

ponents causing significant fractures; finally, in addition to what is described in the thematic plan of the case study (Figure 11), the low or zero resistance to tensile stresses that the adobe construction system has is emphasized.

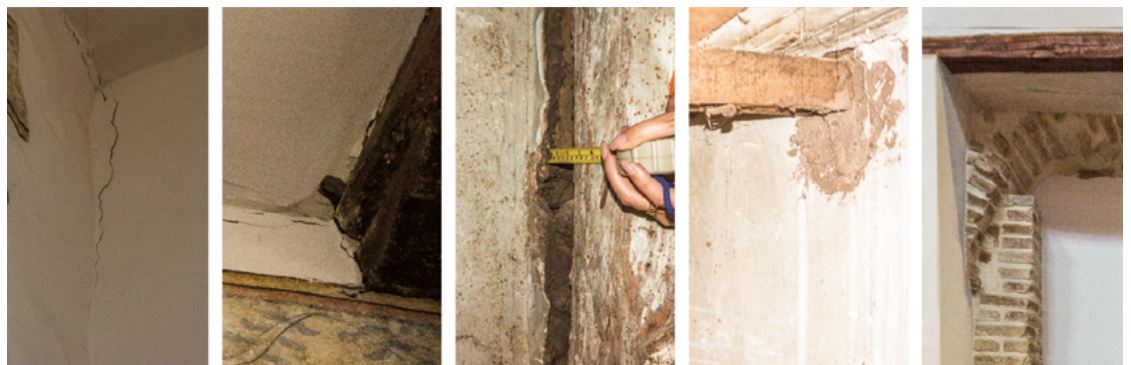
FIGURE 13. Secondary threats of urgent intervention in property (Photo: Gema Zamora, 2018; courtesy: Aguirre Ullauri, Cajamarca Zúñiga, & Zamora Cedeño, Ecuador).

Regarding conservation considerations, in order to prevent the loss of built heritage, the INPC (2011, p. 32) recommends intervening in those buildings that, like the church of El Sagrario, show instability in the supports and roofs and have cracks on both sides (Figure 13), mostly present in the earthen ones. If the building is in a state of instability, it is necessary to shore it up without coming into direct contact with the original building materials; the joints of the beams in wooden mezzanines should be checked to avoid possible slipping. Another recommendation is to draw up a risk map of the building, as was done in the building that is the subject of this study (Figure 11), in order to understand in detail the fragile points of the building and to intervene correctly in structural reinforcement and damage mitigation.

to reduce weight; the placement of perimeter beams to ensure the continuity of the anchorage of the wall; and, finally, the rehabilitation with steel mesh and sand and lime mortar that confines the wall to obtain better performance in the event of an earthquake is considered (AIS, 2010, p. 65). The latter is valued for the results it offers, but it is also questioned regarding the compatibility of the intervention in a heritage building. In this sense, any action taken must be supported by an adequate contingency system and, above all, risk assessment before the event, prioritizing preventive interventions rather than restoration after the disaster (Palma, 2015, p. 96).
