The Use of Cob in the Intervention of Adobe Construction Components

Luis Fernando Guerrero Baca

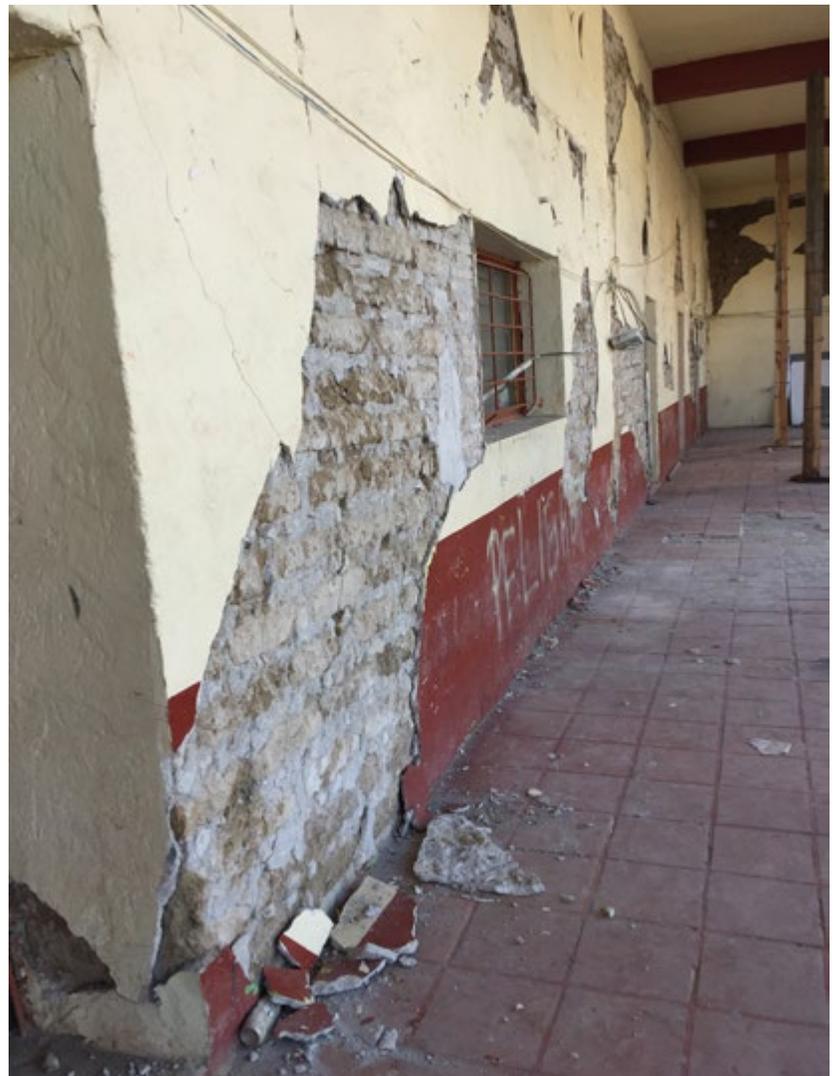
FIGURE 1. The cracks shown in the adobe walls covered with cement mortar were only superficial. Ayudantía Municipal de Hueyapan, Morelos, Mexico (Photograph: Luis Fernando Guerrero Baca, 2017).

several days after the earthquakes and was caused by man, and not by nature. The lack of knowledge about the natural behaviors of adobe construction and the presence of ostensibly fractured cement coverings made inspectors, brigade personnel and even the inhabitants themselves think that the structures were so badly damaged that they would be a permanent danger to their inhabitants. So, hundreds of houses were systematically demolished without anyone taking the trouble to remove the cement linings to verify the fact that, most of the time, the adobe cores were actually intact (Figure 1).

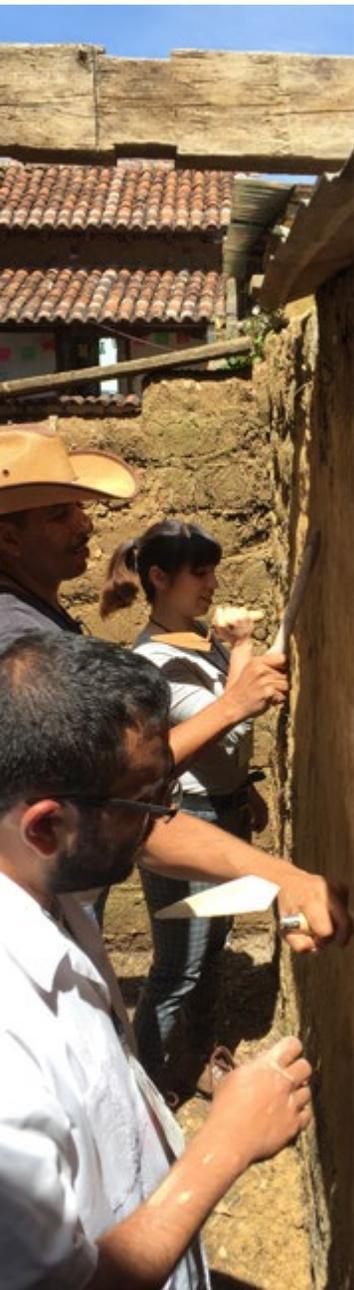
FIGURE 2.
 Restoration of an
 adobe wall during
 the workshop for
 conservators of the
 Centro INAH Chiapas.
 San Cristóbal de
 Las Casas, Mexico
 (Photograph: Luis
 Fernando Guerrero
 Baca, 2018).

This text presents some of the laboratory obtained results, both in scaled prototype models and in restoration interventions, an area in which the use of soils opens up a wide range of actions, since it makes it possible to space out the preventive maintenance work of heritage buildings over a longer period of time (Figure 2).

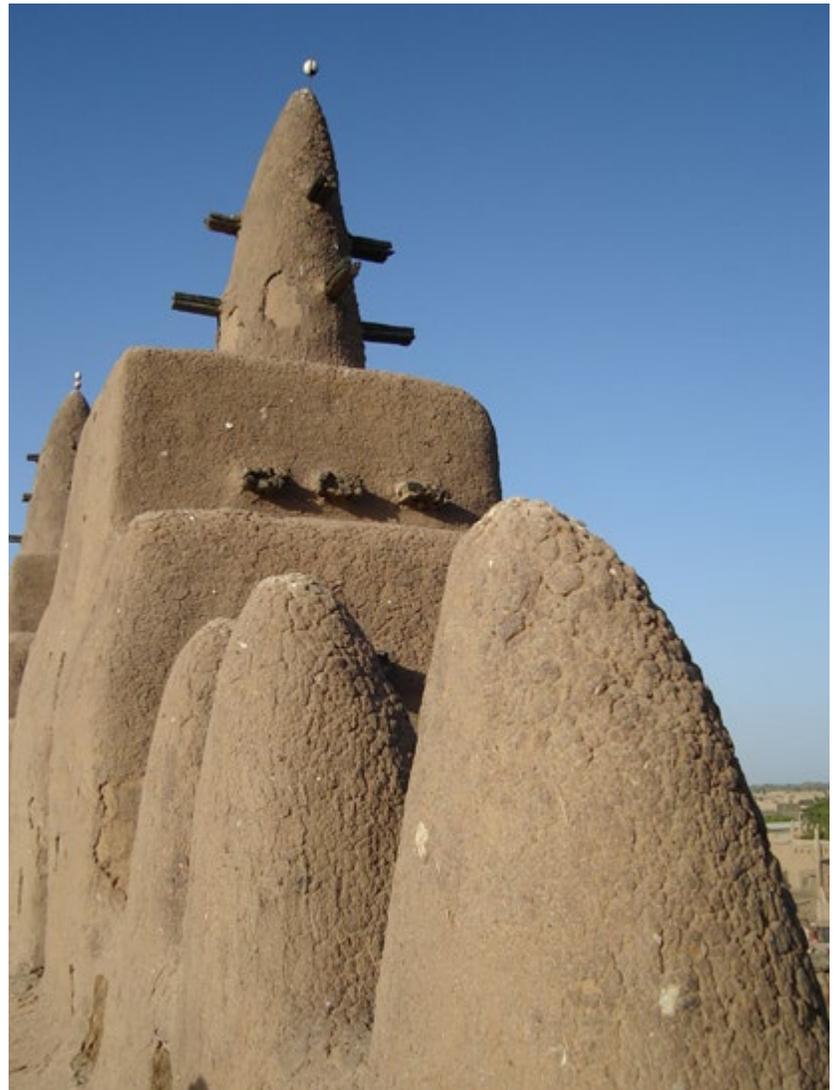
FIGURE 3. The use of clayey soils allows the production of less permeable finishes, but its cracking requires periodic maintenance. Crenellations of the Djenné Mosque, Mali (Photograph: Luis Fernando Guerrero Baca, 2008).

As it is known, soils that have, in comparison with silts and sands, a high proportional ratio of high plasticity clays, generate denser and more resistant constructive components once they dry. However, when they do so, they tend to decrease in volume, generating surface cracks or, if they have been used as coatings, a tendency to become detached from the substrates onto which they were applied (Figure 3).

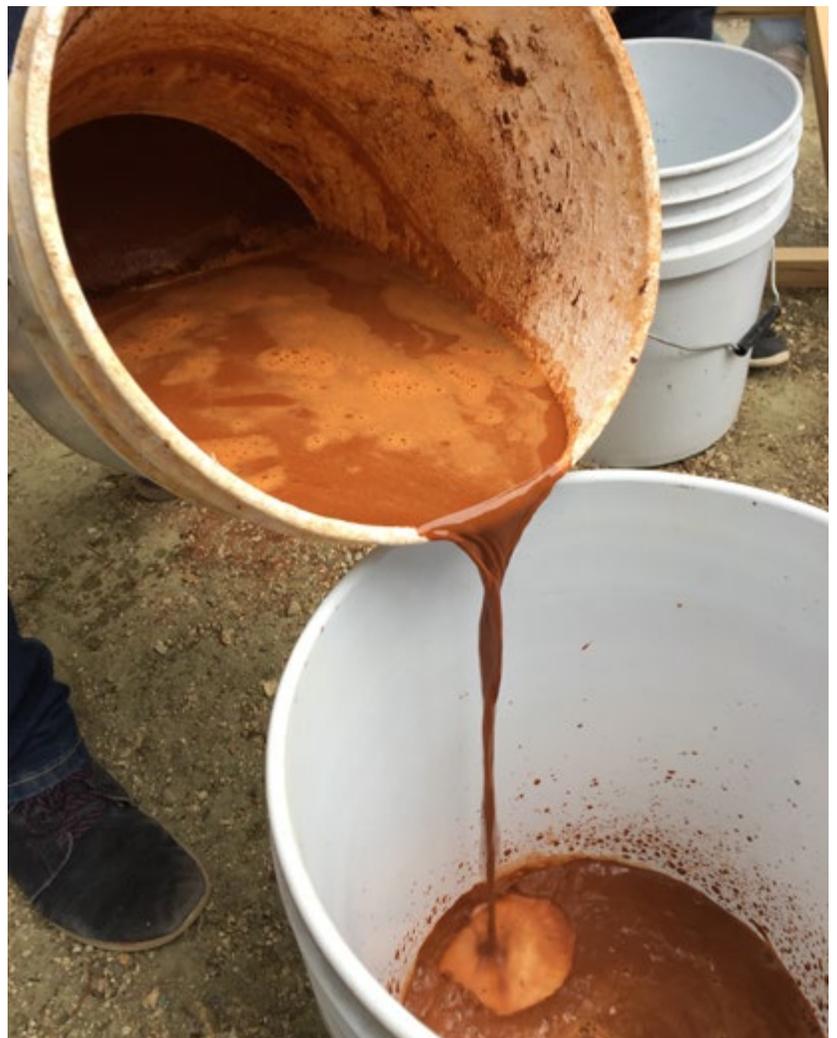
FIGURE 4.
 Decantation of soil
 to extract its clay
 after the silts and
 sands have settled
 to the bottom
 of the container
 (Photograph: Luis
 Fernando Guerrero
 Baca, 2018).

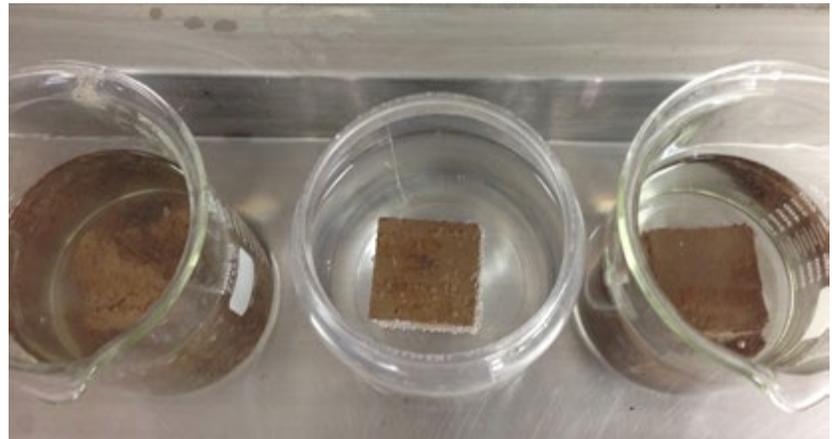
FIGURE 5.
Disintegrated sample, on the left; on the right, the compacted soil sample, and in the center, the stabilized and compacted soil sample remains intact. Laboratorio de Materiales de la UAM-X (Photograph: Luis Fernando Guerrero Baca, 2015).

Among the most relevant of the results is the fact that the samples of natural compacted soil, compensated with sand, and the same mixture, but enriched with lime, managed to increase their

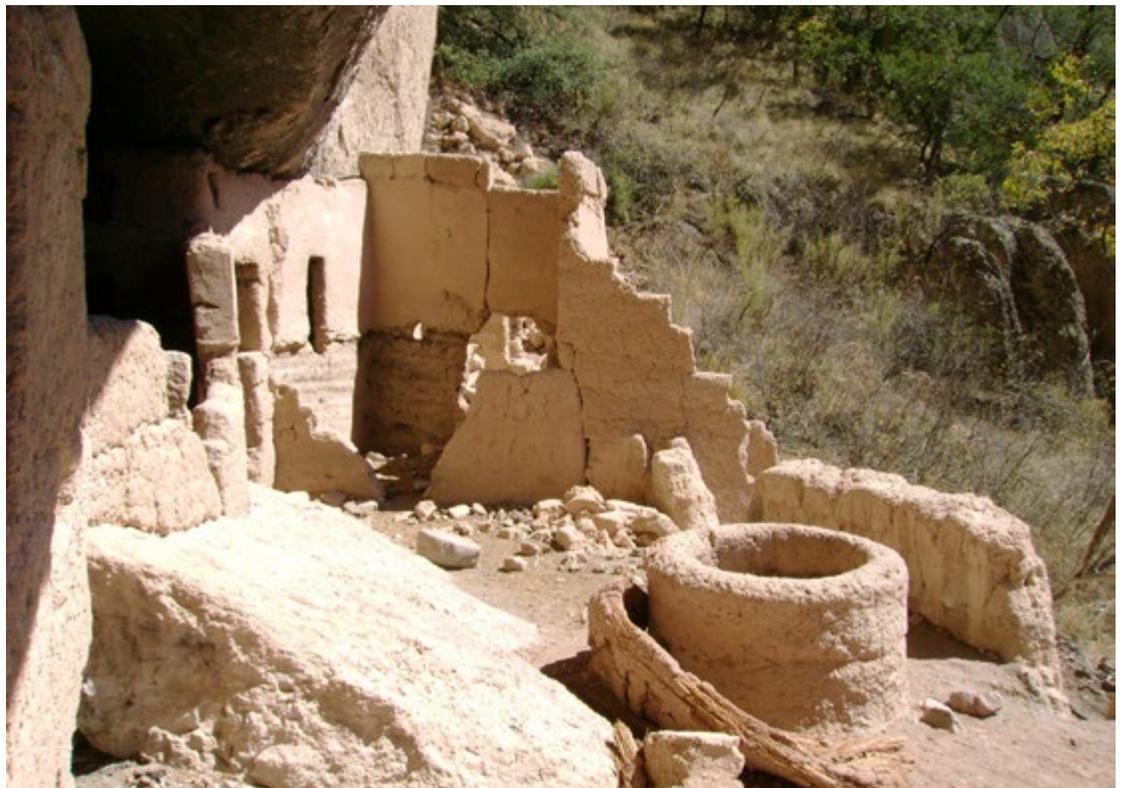
FIGURE 6. Ruins of Sirupa, Chihuahua, Mexico (Photograph: Luis Fernando Guerrero Baca, 2007).

As the material dries, it is tapped by hand, feet or with a wooden tool to densify it and make a continuous mass that transforms into a layer that will remain attached to the rest of the construction, constituting monolithic components. Although the technique has been mainly used to build foundations, walls, ramps and staircases, it has also been used for flooring and roofs supported by wooden structures, as for example, in the Cliff Houses of the Sierra Tarahumara as well as in the ancient city of Paquimé, in Chihuahua (Figure 6).

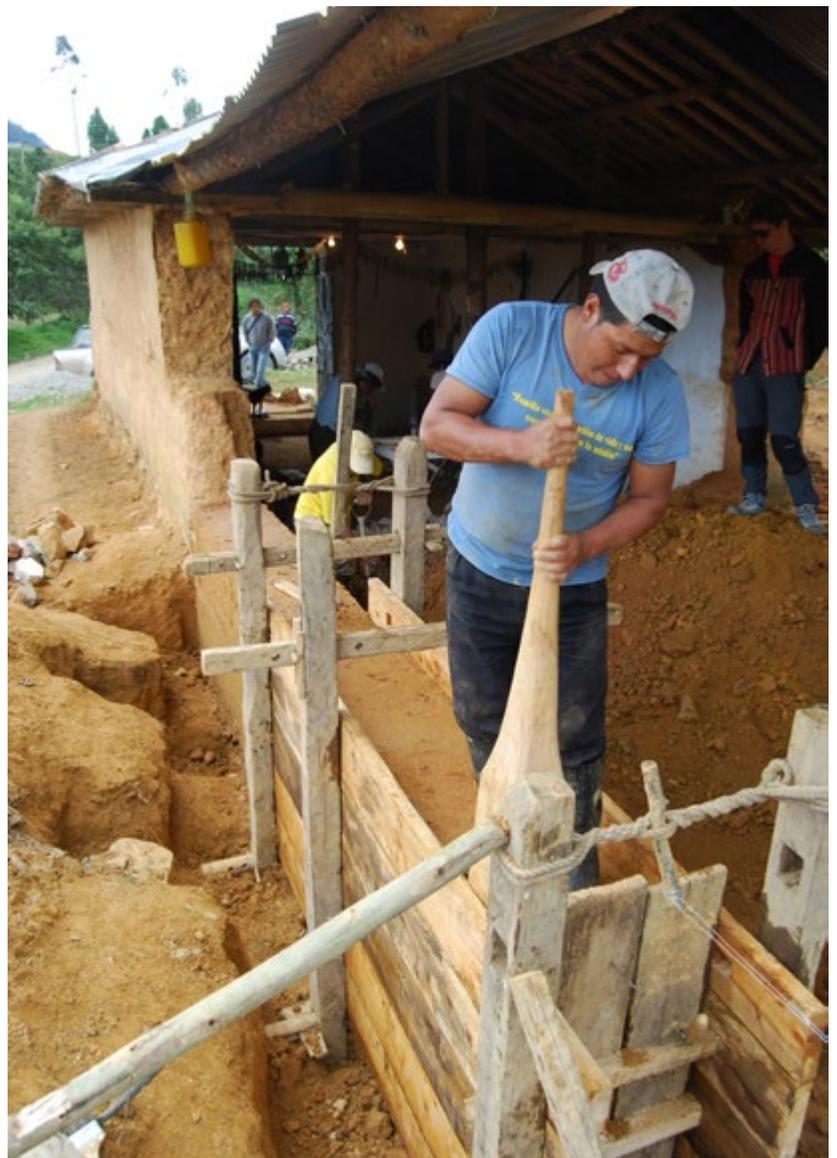
FIGURE 7.
 Restoration of a
 tapia heritage chapel
 in Chuquiribamba,
 Ecuador
 (Photograph: Luis
 Fernando Guerrero
 Baca, 2014)

There are notable examples of rammed earth buildings in North Africa, India, China, southern Spain, Germany and France, but they were erected with a much newer approach than the ancient method of kneaded and modelled earth. Furthermore, it is important to note that to date, no pre-Columbian ruins of rammed earth walls have been found, so it seems that the technique reached the continent from around the 16th century, during the Conquest (Guerrero, 2018, p. 136) (Figure 7).

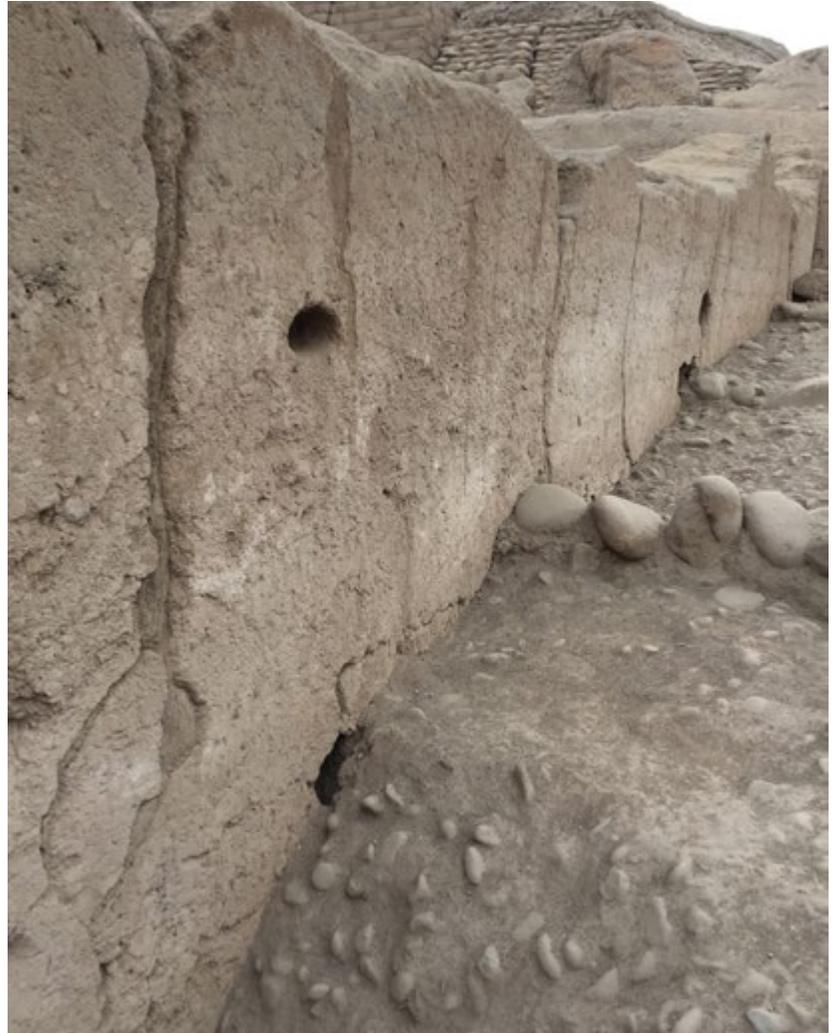
FIGURE 8. The archaeological walls of the Bellavista site in Lima, Peru, gave the false impression of having been built using the rammed earth technique, but their patterns of deterioration are evidence of the use of kneaded earth in a plastic state (Photograph: Luis Fernando Guerrero Baca, 2017).

were made with plastic soil that retracted upon drying, since this phenomenon would not occur in the case of real rammed earth, because, as explained above, sandy and almost dry soil is used to compact it (Figure 8).

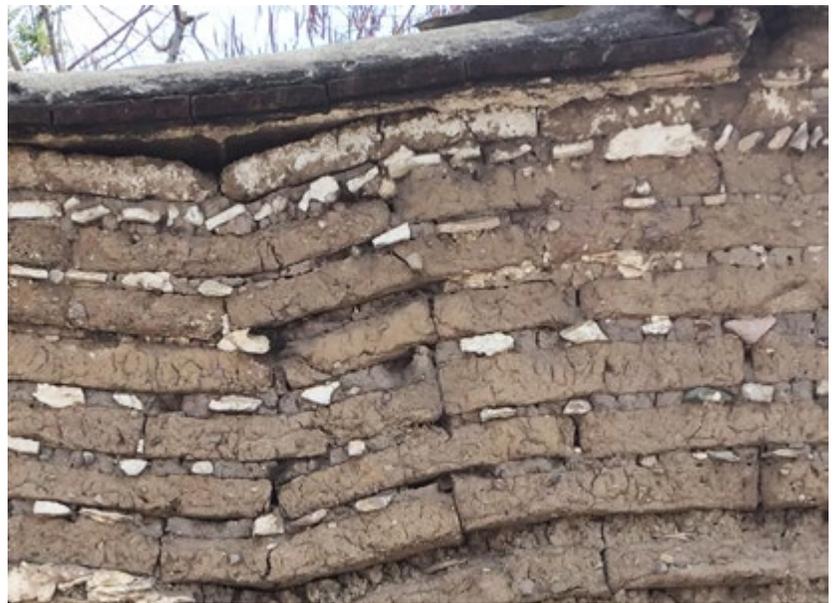
FIGURE 9. Adobe, unlike other masonry products, has the ability to deform within certain limits. Huehuatlán El Chico, Puebla, Mexico (Photograph: Luis Fernando Guerrero Baca, 2018).

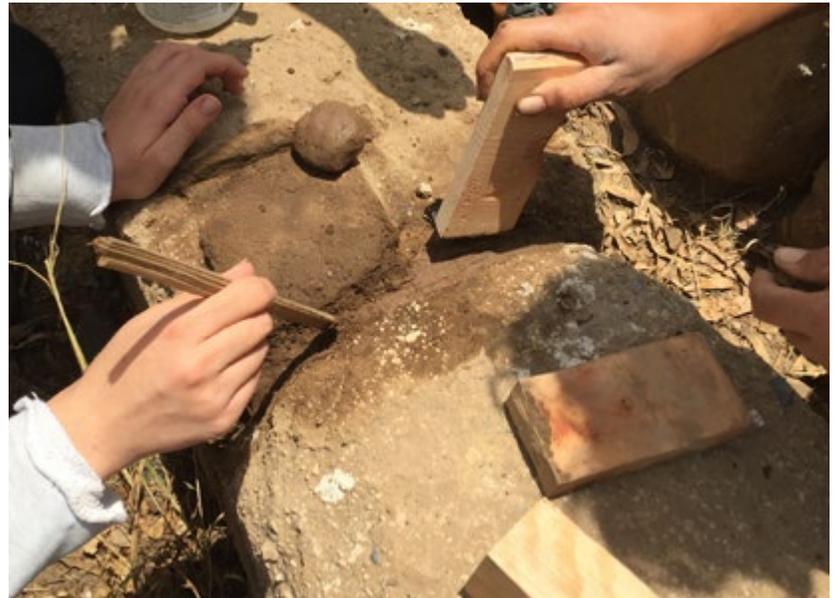
FIGURE 10. Refilling of cracks during a workshop of the Bioconstruction Immersion Program. San Isidro Project, Tlaxco, Tlaxcala, Mexico (Photograph: Luis Fernando Guerrero Baca, 2019).

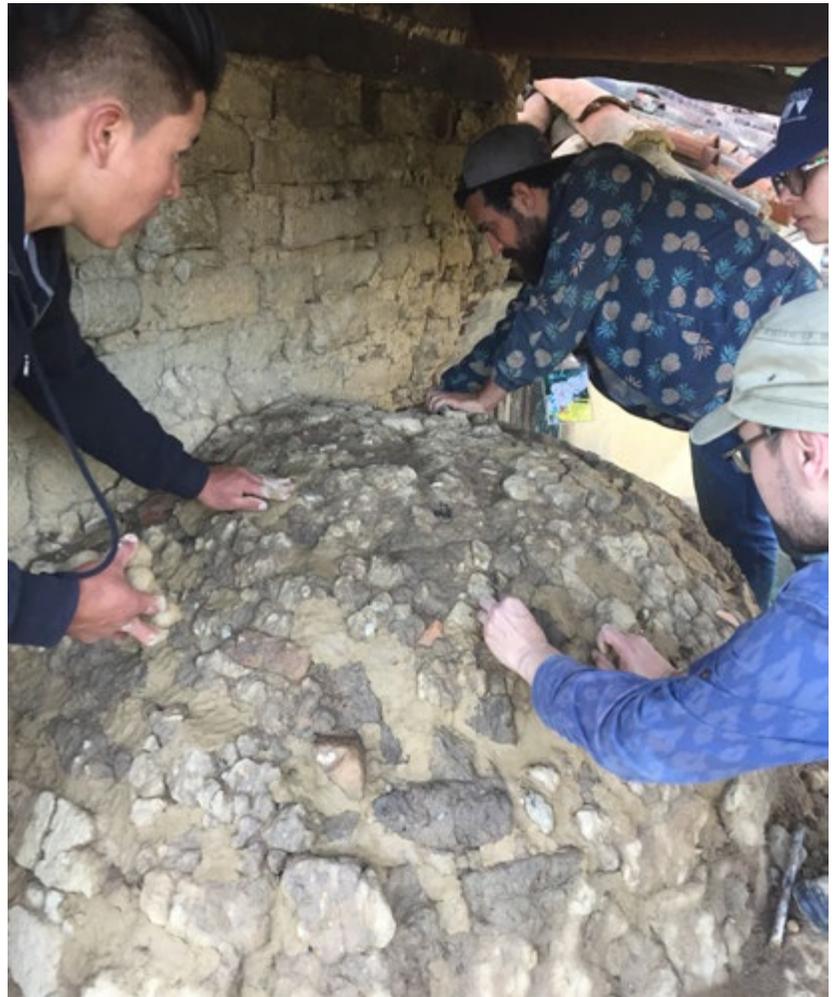
FIGURE 11.
 Restoration of
 a heritage oven
 during a workshop
 for conservators at
 the Escuela Taller
 de Boyacá, in Villa
 de Leyva, Colombia
 (Photograph: Luis
 Fernando Guerrero
 Baca, 2018)

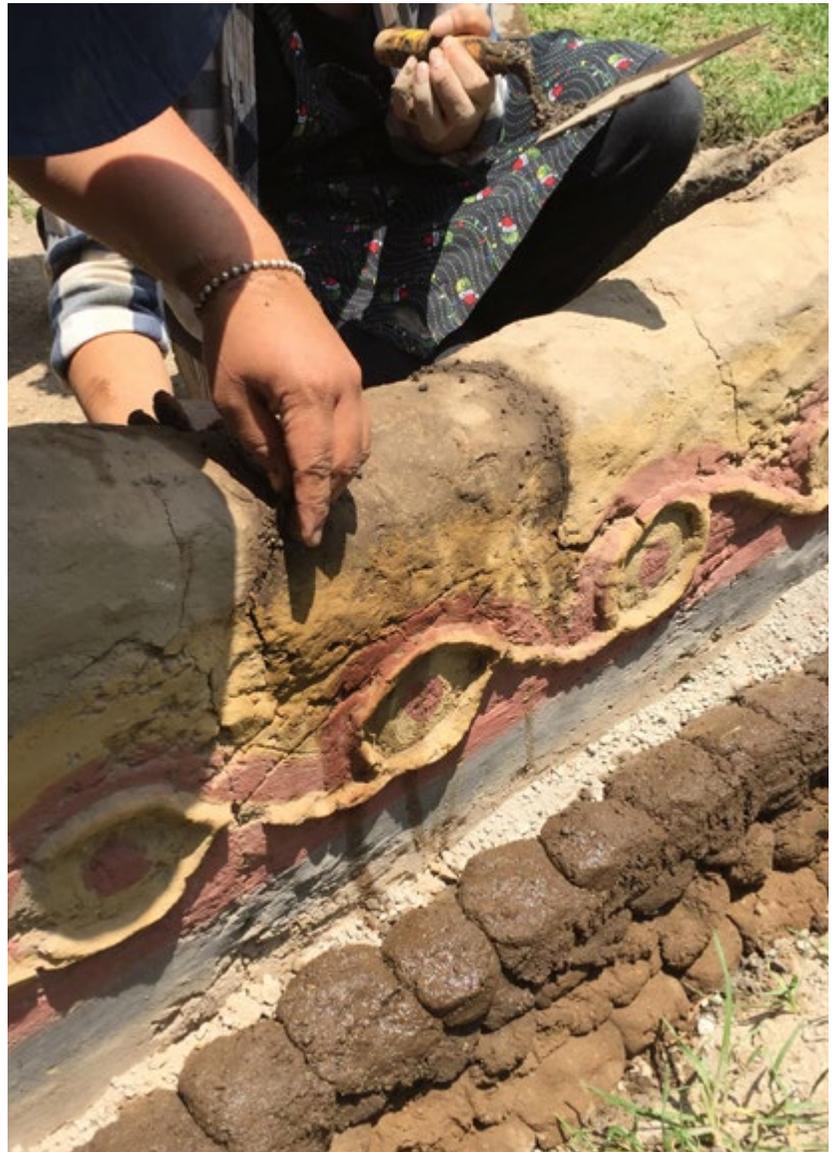
FIGURE 12. Practice of consolidation and re-burial using modeled soil in the classes of the Master's Degree in Conservation and Restoration of Built Heritage of the ENCRYM-INAH (Photograph: Luis Fernando Guerrero Baca, 2019)
