Weathering effects of an historic building in San Francisco de Campeche, Mexico

This RESEARCH presents a qualitative description of the degradation phenomena that occurred in external walls of the San Carlos Bastion, San Francisco de Campeche, Campeche City, (Mexico), a military structure built with calcareous materials between 16th and 17th centuries. Several weathe-

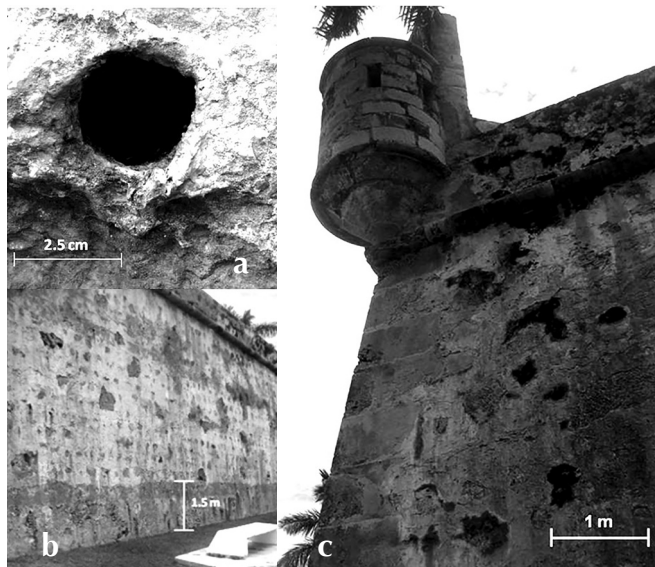
Direct observation of the San Carlos Bastion showed water discharge structures widely distributed at different heights along the walls. The structures were round-to-oval shaped, forming cavities with diameter from 2 to 5 cm (Figure 2).

FIGURE 2. Different weathering effects at San Carlos Bastion: (a) Water discharge structures. Efflorescence and crust formation can be observed outside; (b) Alternation stripe observed at the north wall; (c) Preferential limestone quarry block degradation at west wall (Photograph: Javier Reyes, 2010).

During rainfall events, water flows from the roof across the inner masonry structure. The flowing water leads to dissolution processes of calcareous stone fragments, while their binders, also calcareous, drain outside the wall. Several dissolution structures form and neomineral CaCO_3 crust crystalizes as a natural consequence of the acid hydrolysis of calcium carbonate induced by the CO_2 content in water, according to the mechanisms described by Samaouali (2010:1171 [Figure 3]):

over stone blocks without mortar. Moreover, hydration/dehydration cycles are favored by cyclic change on atmospheric humidity. The expansion of salts cause granular disaggregation and cracks on mortar and stone

The capillary action produced wet zones from the base of the walls up to a height of 1.20 meters where the binder content in the mortar was dissolved. Some areas of the building with modern cements –made using limestone, shells, chalk (CaSO_4) or/and marl combined with shale, clay, slate, blast furnace slag, silica sand, and iron ore (PCA 2015)– suffered a similar process. This generated cracking, cavities, crumbling and disintegration, leaving the particulate materials in conditions to be removed by the fluvial and eolian erosion processes.

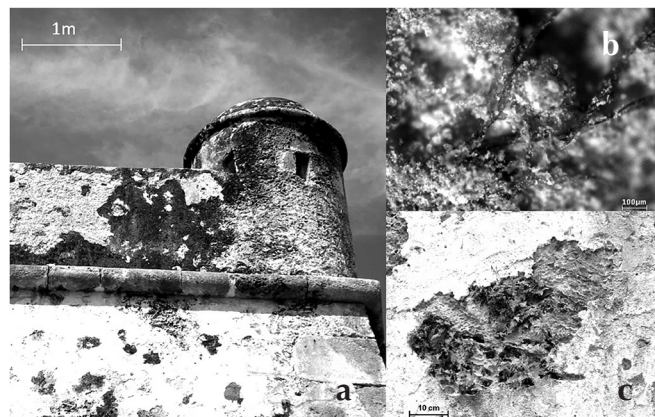
Many forms of biological weathering affect the stone and the mortar substrates in the San Carlos Bastion (Figure 4). In tropical climates, the high water availability allows the development of biological agents. Their role as damage agents depends on the metabolic activity of the organisms and the environmental conditions; for instance hyphae penetration causes disintegration and breakdown of stone and mortars structures, whereas lichens induce the formation of bio-mineralization by-products because of organic

FIGURE 4. Biological activity at the San Carlos Bastion: (a) General view of biological colonization formed over east wall; (b) Mortar disintegration induced by hyphae penetration; (c) Mortar damage —consequence of biological activity— (Photograph: Javier Reyes, 2010).

acid secretions (Gehrmann 1992:37). Chromatic changes commonly cause the appearance of colored bio-deposits or patinas that affect the building's aesthetics. These chromatic changes, however, reduce the effect of water and wind erosion. Moreover, biological colonization expands and contracts according to water availability, causing disruptive forces in the wall components.⁴

Furthermore, sediments are deposited inside fissures and cavities –formed during karstification processes– by biological activities, wind and water flow. Inside, small plants and their roots produce dislocation and fracture leading to the formation of numerous sites for new plant growth (Figure 4). As a natural consequence, insects and birds also colonize the building.

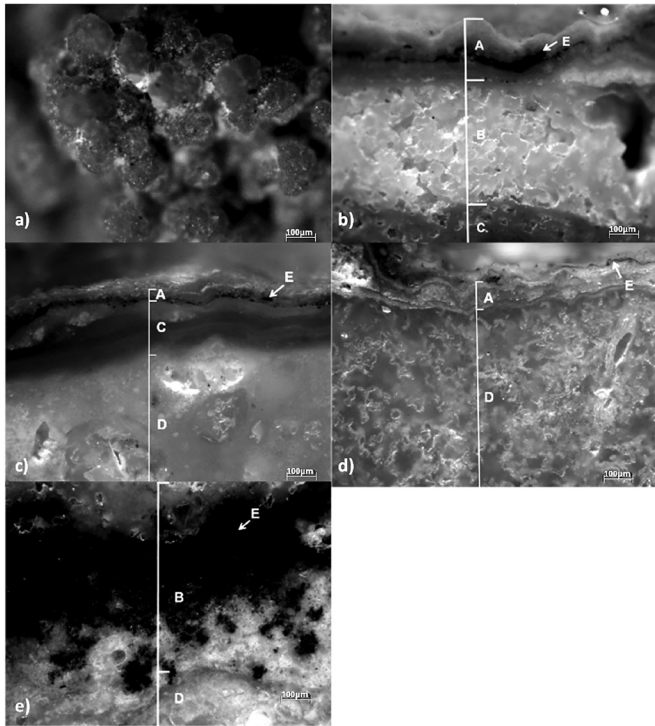
Figure 5a shows an optical image (4X) from a typical crust, a sample obtained from external water discharge conducts; the results of EDS chemical analysis carried out in the 18 samples are synthesized in Figure 6.

Crusts have an irregular morphology and compact structure formed from accumulation of blisters, with an inner growth of characteristic round-shape structures. Some mortar samples without crust presented a brittle and fragile aspect, as a consequence of severe weathering caused by hyphae penetration as illustrated in figure 4. The calcareous stone samples are highly porous and usually have microcracks with endolithic microorganism growth inside.

FIGURE 5. (a) Internal structure from a crust taken from outside water discharge conducts; (b and c) Cross sections (5X) of damaged layers from selected mortar samples. Cross sections (5X) of damaged layers of selected limestone samples (d and e) (Analysis: Isabel Silva-León, 2013).

Microscopic observation of *cross sections* revealed the structure of the degradation layers of stone and mortar samples. Mortar crust showed a thickness from 120 to 1500 μm (Figure 5b). It has an external crystallized calcium carbonate layer (A). An internal white, highly porous structure (B) was observed overlapping the paint layer (C) located over the mortar matrix (D). On the other hand, stone crust samples presented a thickness from about 200 to 900 μm (Figure 5d-e). The crust was composed of an external calcium carbonate layer (A) covering an internal porous layer (B), formed adjacent to the stone support (D). It is important to note that in most of the samples, the mineral structure of the crust causes the appearance of thin layers entrapped within the crust. These layers of residual biomass have a black color (E) and lack a preferential distribution.
